Pincas de dépannage - Notfallspannzangen - Emergency collets

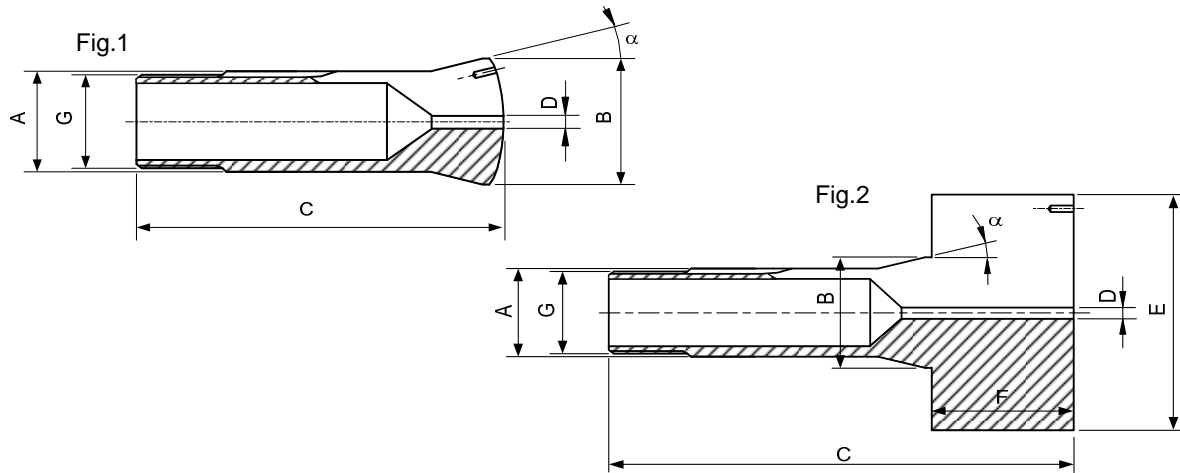
Type	Art.	A	B	C	D	E	F	G	α	Fig.
W12 10) 80-2	80-52200	12	16	45.6	1.5	-	-	\emptyset 11.75x1.25 ∇ 45°/5°	15 °	1
	80-50315 14)	12	16	45.6	1.5	-	-	\emptyset 11.75x1.25 ∇ 45°/5°	15 °	1
W20 10) 80-4	80-50300	20	26.3	73	2	-	-	\emptyset 19.7x1.666 ∇ 45°/5°	15 °	1
	80-50314 14)	20	26.3	73	2	-	-	\emptyset 19.7x1.666 ∇ 45°/5°	15 °	1
	80-52365	20	26.3	105.6	6	47	35	\emptyset 19.7x1.666 ∇ 45°/5°	15 °	2
W25 10) 80-5	80-50294	25	33.7	97.6	2	-	-	\emptyset 24.7x1.693 ∇ 45°/5°	15 °	1
	80-50344 14)	25	33.7	97.6	2	-	-	\emptyset 24.7x1.693 ∇ 45°/5°	15 °	1
	80-53004	25	33.7	129	6	47	35	\emptyset 24.7x1.693 ∇ 45°/5°	15 °	2
W31.75 10) 80-842	80-52531	31.75	37.4	87	2	-	-	\emptyset 31.4x1.27 ∇ 60°	10°3'	1
	80-53000 14) & 26)	31.75	37.4	87	2	-	-	\emptyset 31.4x1.27 ∇ 60°	10°3'	1
B6 10) 72-128	72-53005	6	10.5	31.3	1	-	-	\emptyset 5x0.706 ∇ 55°	20°	1
B8 10) 72-137	72-53000	8	13	35.5	1.2	-	-	\emptyset 6.82x0.625 ∇ 55°	20°	1
B32 10) 72-65	72-50615	32	40	106	2	-	-	\emptyset 29.7x1.693 ∇ 45°/5°	15 °	1

72-52525	32	40	137	6	60	35	\emptyset 29.7x1.693 ∇ 45°/5°	15 °	2
	72-52290 14)	32	40	106	2	-	-	\emptyset 29.7x1.693 ∇ 45°/5°	15 °	1
B45 10) 72-199	72-53001	45	53	115	3	-	-	M42x1.5	15 °	1
